# Tips & Tricks

## Smart building system UWP 3.0

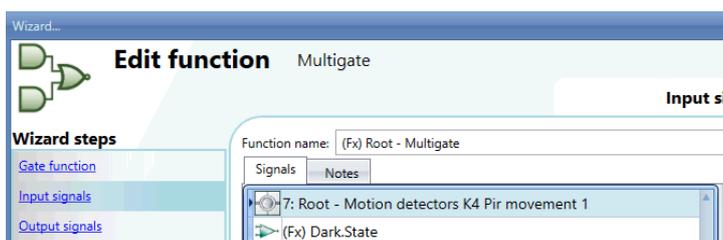
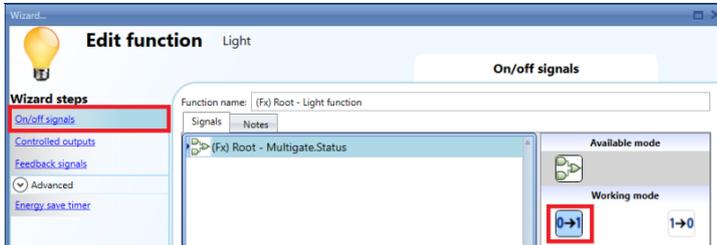
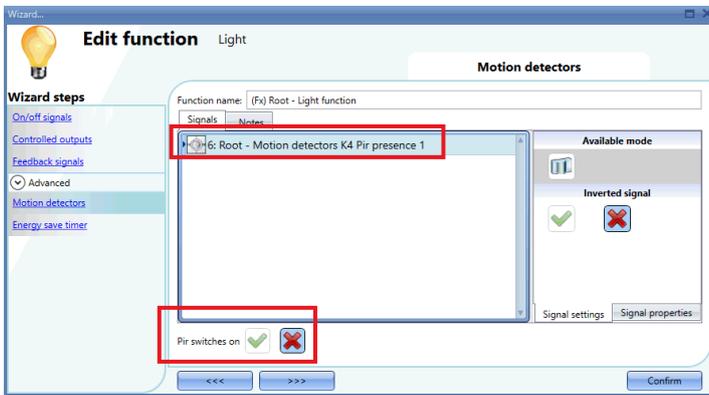
### ***Energy save timer is not reloaded when the light level is above the threshold***

The automation of the light function puts together lux meter, PIR and energy save timer. When the lux value is below the threshold and the PIR detects movement, the light goes on. At this point the lux value goes above the threshold and the energy save timer is not reloaded anymore, therefore the light goes off even if there is presence in the room.

Create an external analogue comparator that is used to define the “dark” condition. Use the comparator function as input of a multigate “AND” function combined with the *movement signal* of the PIR sensor.

Use the multigate as input signal (*On/Off Signals* tab) of the Light function.

In the light function, add the presence signal of the PIR.

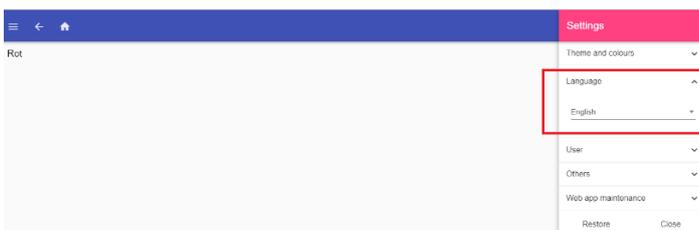
## ***Reports created from web App shows wrong month***

In the web app *Reports* window, you have created a template for a report in October 2018 but when you save and create the report, November 2018 data logs are shown.

The problem is due to the wrong default language that is automatically set by the Web App.

To fix this issue, navigate the web App settings, select the English language, then select again the correct language and save to apply the settings.

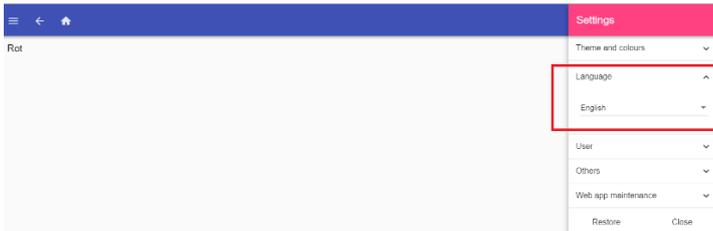
## ***Not possible to edit calendar activity from the web App***

When you try to edit a calendar activity from the Web App, you get an error and the login page is shown.

The problem is due to the wrong default language that is automatically set by the Web App.

To fix this issue, navigate the web App settings, select the English language, then select again the correct language and save to apply the settings.

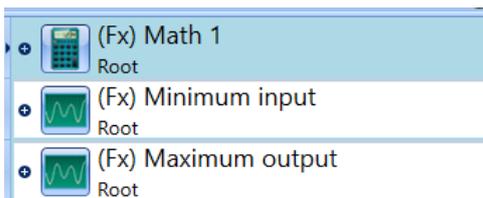
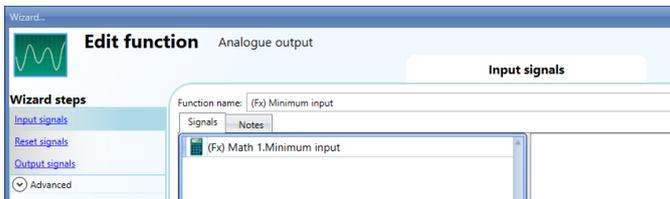
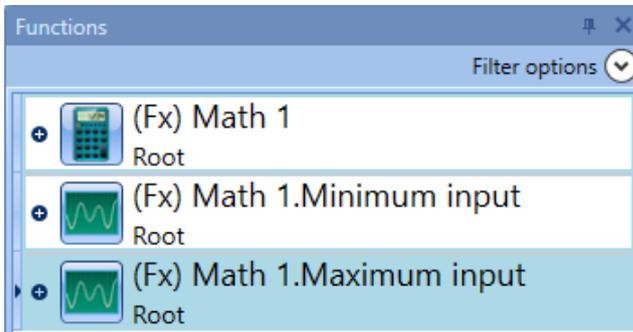
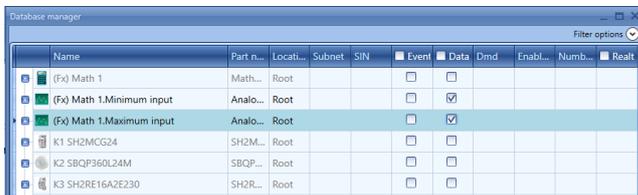
## ***Not possible to log additional function status in the Database***

In the Database window, the additional function status of a function is not available and it is not possible to log them into the Database of the system.

- a. Add to the project one Analog Output function for each additional status not available in the Database.

- b. Add to the analogue output function the additional status of the math function.

- c. Change the name of the Analog Output functions in order to have a clear description of the additional status (es. function\_name” + “additional\_status”).

- d. In the DB Manager add to the Database the Analog Output function.

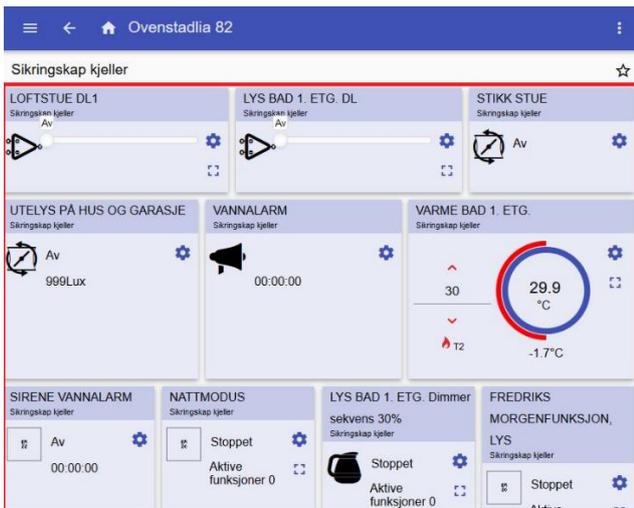
## Wrong icons shown in the web App

After a firmware upgrade of the system the icons in the web App are not correct (the icons are messed up or missing).

The error is due to the cache of the web browser, the issue will be resolved cleaning the cache and logging-in again in the web App.

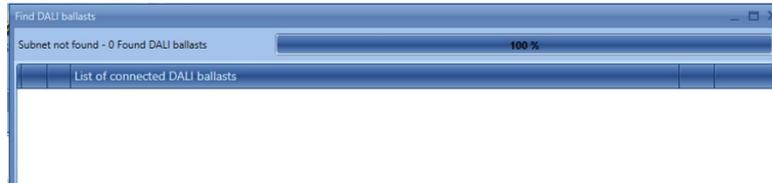
## ***Not possible to scan the DALI network “subnet not found” error message appears***

After adding the DALI module to the project, from the DALI module discovery window, the user tries to find the ballast connected, but when the search button is pressed, the discovery ends immediately with an error “Subnet not found”

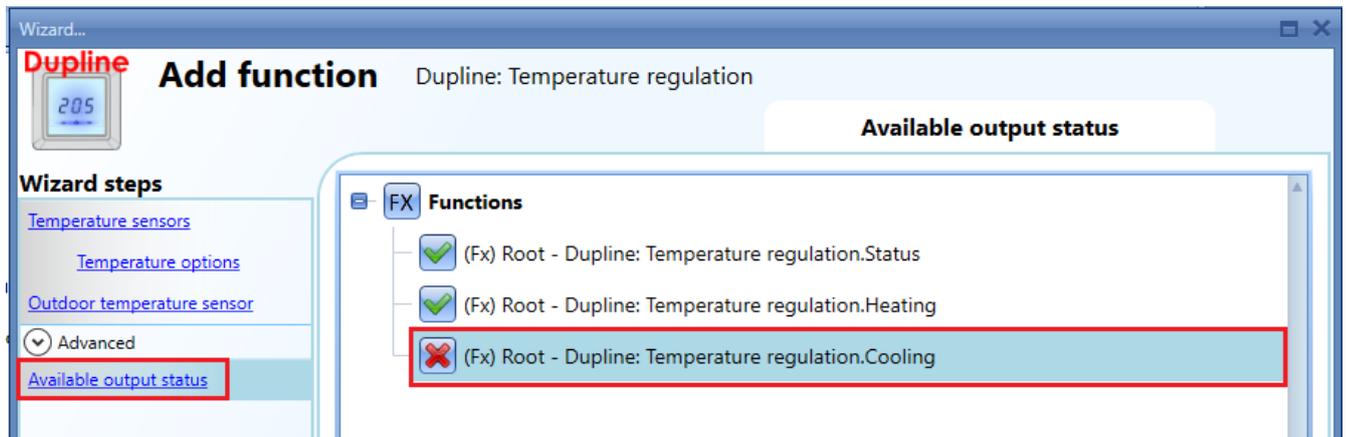
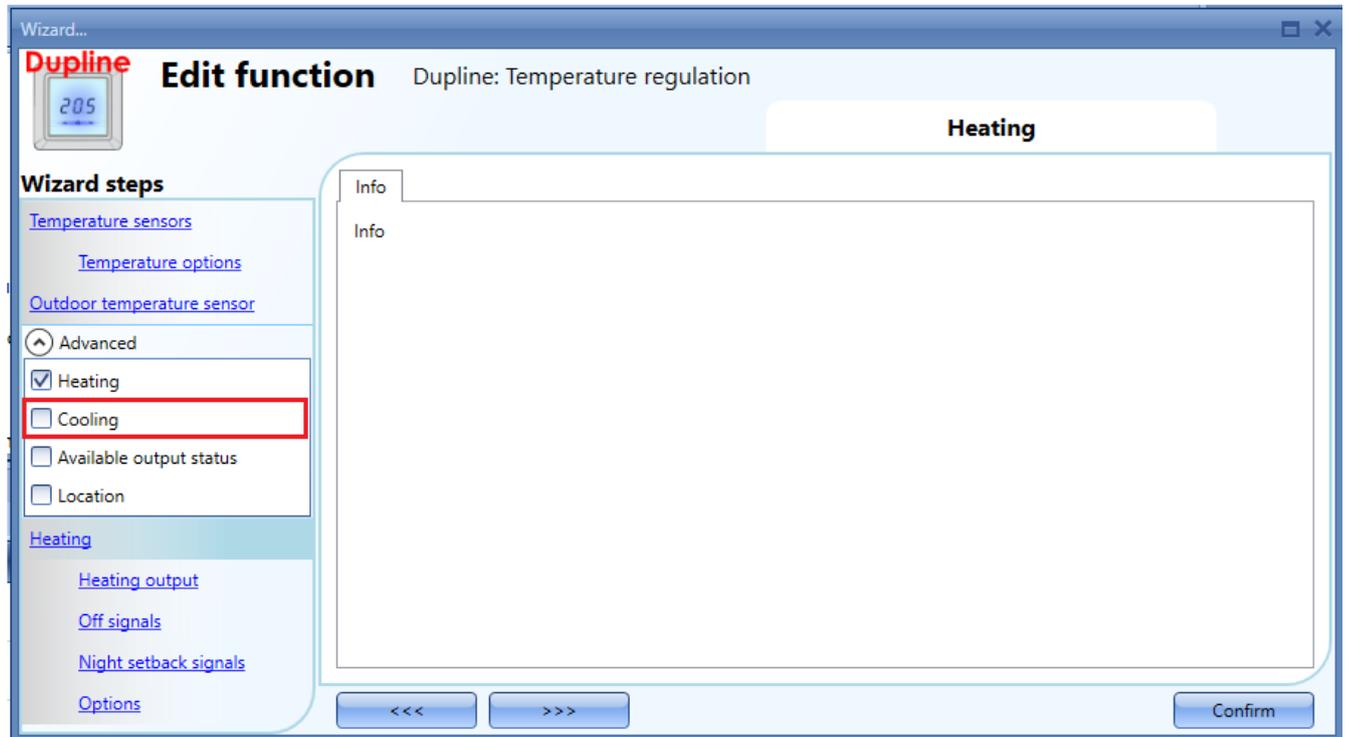
## Dupline temperature regulation function deactivates the heating setpoint

When the advanced field Cooling is selected in the Dupline temperature regulation and there is no output signal used, the temperature function activates the cooling set point every time the configuration file is sent to the controller, consequently the heating function goes from heating T1 to TOFF and stops heating. This problem happens also when the controller restarts because the system loads the configuration at start-up and the cooling setpoint is activated.

In the advanced menu “available output status” the signal *temperature regulation.Cooling* should be deactivated.

The advanced menu “Cooling” should be unselected.

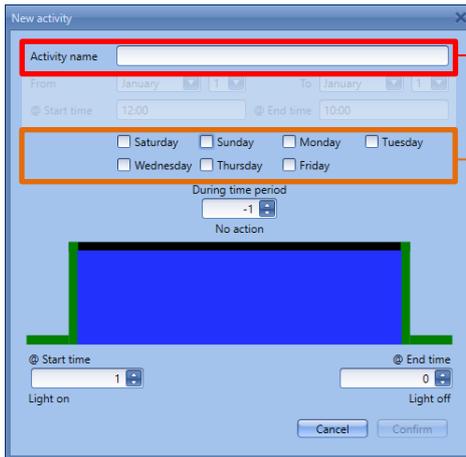
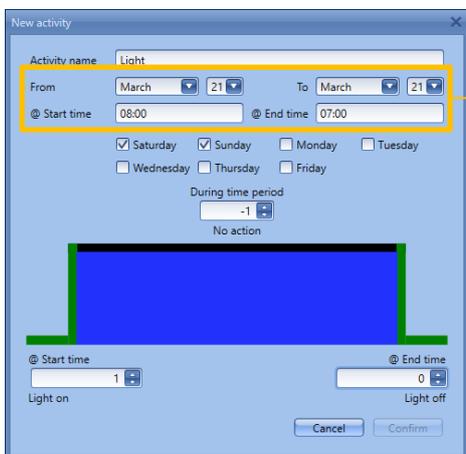
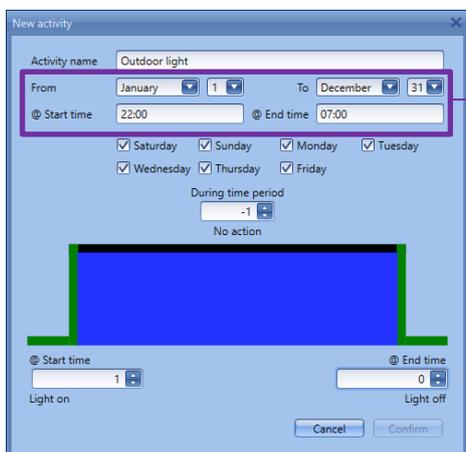
## Calendar activities cannot be added

When a calendar activity is going to be added either in the *Local calendar* of the functions where it is available in the *Advanced* options, or in the *Global calendar* function, after filling the required fields the *Confirm* button cannot be pressed (this is shown in grey colour).

This happens if at least one of the following conditions is verified:

The *Activity name* field has to be entered

At least one week day has to be selected

**a)** With the same selected interval date (*From... To...*), it is necessary to set *@Start time* chronologically prior to *@End time*

**b)** Even with a different selected interval date (*From... To...*), it is still necessary to set *@Start time* chronologically prior to *@End time*

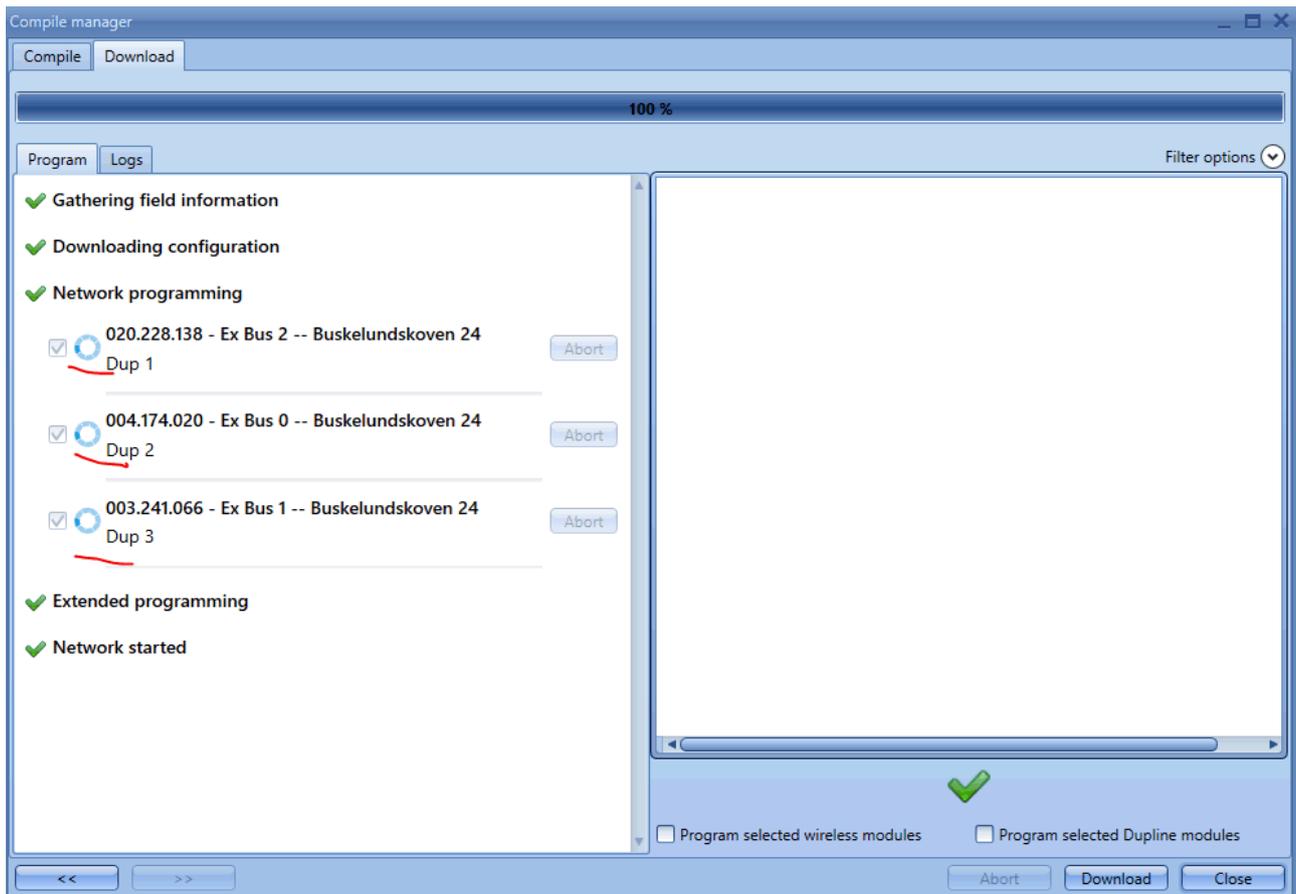
## Configuration upload failing – Intruder alarm function and stress lights

Configuration upload failing after a modification of the stress light functionality in the intruder alarm function and the system does not work as expected (no error is shown when the software compiles the configuration). This problem occurs every time a light function is added as “stress light” signal in two or more intruder alarm functions.

It is mandatory to use each light function in one single *stress light* functionality

*Note: It is not possible to add the same function in two or more different stress light fields.*
